CHAPTER 12

Waste-to-Energy Boilers and Waste Incinerators

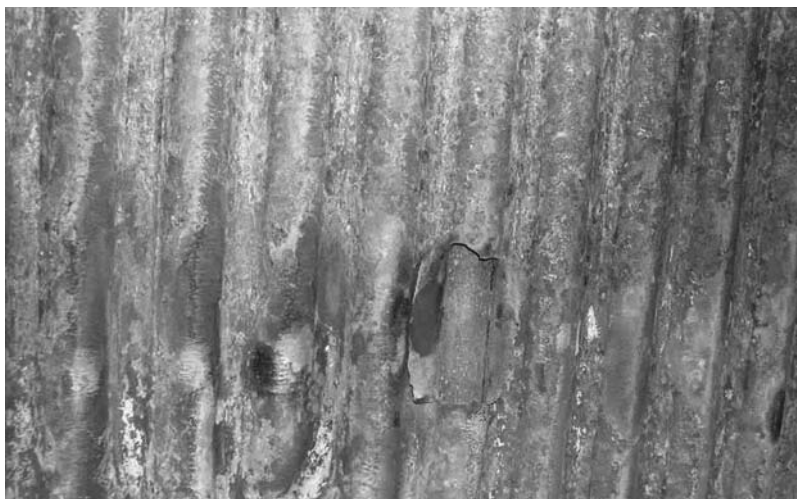
Fig. 12.4 Carbon steel waterwall suffering blown tubes due to high wastage rates resulting in significant tube-wall thinning after 8 months of service in a WTE boiler. Courtesy of Welding Services Inc.

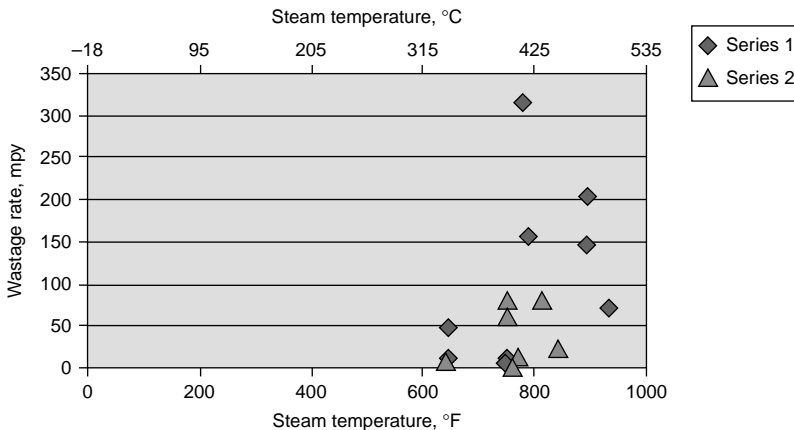
Fig. 12.6 Wastage rates as a function of steam temperature for alloy 625 cladding in weld overlay tubes and coextruded tubes tested as part of superheater tube bundles at various WTE boilers. Source: Ref 10, 22

in some very aggressive boilers, as shown in Fig. 12.6. It is thus believed that the severe corrosion of the alloy 625 overlay (or cladding) superheater tubes was most likely due to molten ZnCl_2 and/or molten PbCl_2 . Because of considerable scattering in the data, the test results were not adequate for making an alloy ranking among nickel-base alloys. X-ray diffraction analysis of the scale and corrosion products was performed on alloys C-22, 625, G-30, 825, HR-120, and Type 310, showing mainly Cr_2O_3 and NiCr_2O_4 for all alloys, with NiSO_4 being detected for C-22, 625, 825, and Type 310 (Ref 33).

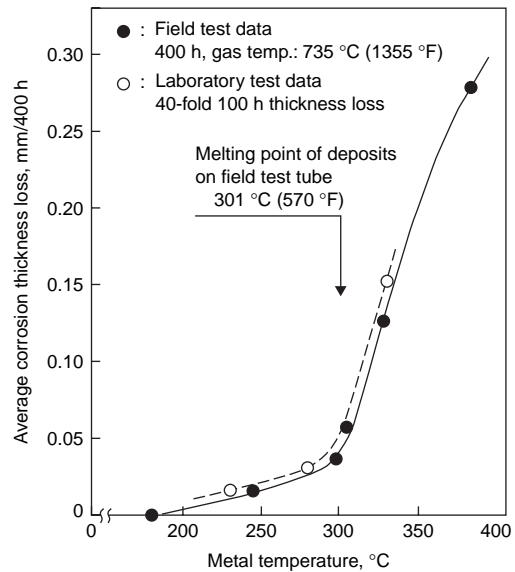
Fig. 12.7 Corrosion in terms of thickness loss for carbon steel (SA178) as a function of the metal temperature in field exposure tests. Also superimposed are data generated from laboratory tests. Source: Ref 31

Kawahara and Kira (Ref 31) observed that the corrosion rate of carbon steel changed to a much higher rate above approximately 300 °C (150 °F), which corresponded to the melting point of the deposits collected from the tube samples in field testing. This is illustrated in Fig. 12.7. They also performed laboratory tests, which involved actual deposits collected from the boiler to which ZnCl₂ was added as 8% ZnO. The laboratory data conformed well with the field data. The temperature at which carbon steel suffered accelerated corrosion attack was found to coincide with the melting point of the boiler tube deposits. The data strongly suggest that accelerated corrosion attack in the WTE boiler combustion environment was caused by the formation of molten phases in the tube deposits.

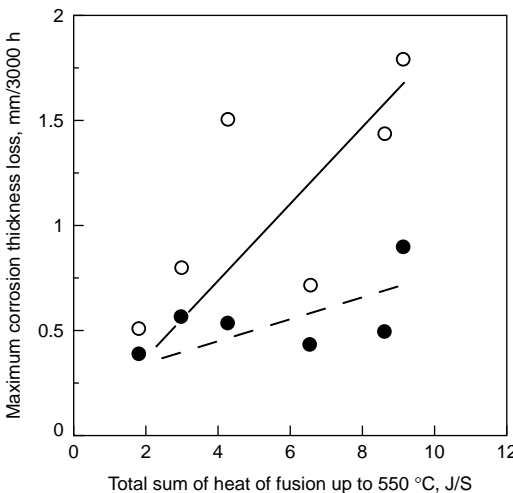
Fig. 12.9 Maximum thickness loss of corrosion probes exposed at metal temperature 550 °C (1020 °F) for 3000 h in WTE boilers as a function of the sum of heat of fusion (corresponding to the amount of fused salt) of the deposits. The open data points are Type 347H, and the solid data points are alloy 625. Source: Ref 32

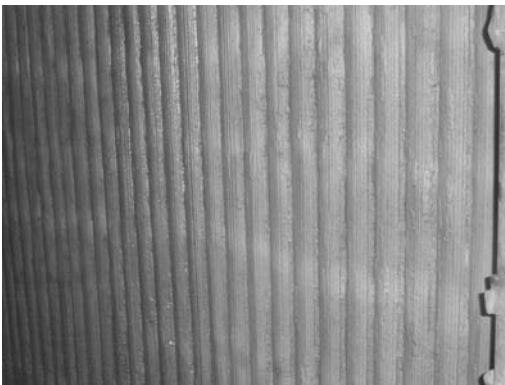
Fig. 12.18 General view of an overlaid waterwall with alloy 625 overlay in a WTE boiler. Courtesy of Welding Services Inc.

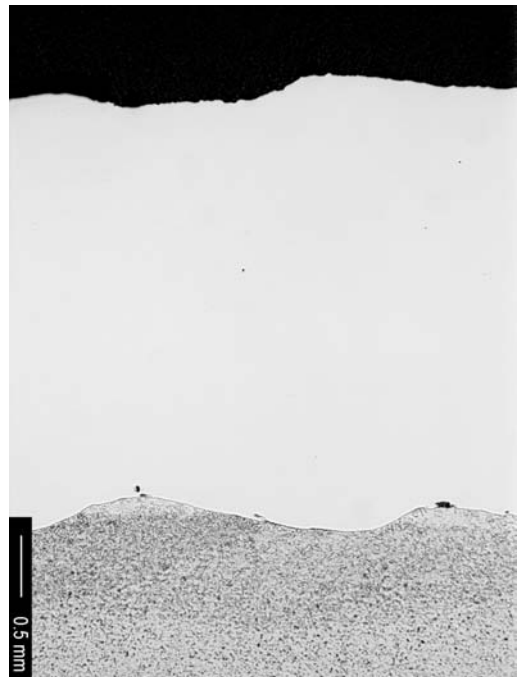
Fig. 12.20 Optical micrograph showing the cross section of the alloy 625 overlay of an overlaid waterwall sample (Fig. 12.19) obtained from a RDF boiler (Lawrence, MA) after 16 years of service. Micrograph also shows the fusion boundary and substrate carbon steel. Courtesy of Welding Services Inc.

Figure 12.19 shows the cross section of an overlaid waterwall tube sample obtained from a RDF boiler in Lawrence, MA after 16 years of service. The metallographic cross section of the alloy 625 weld overlay of that overlay waterwall tube is shown in Fig. 12.20, revealing the full

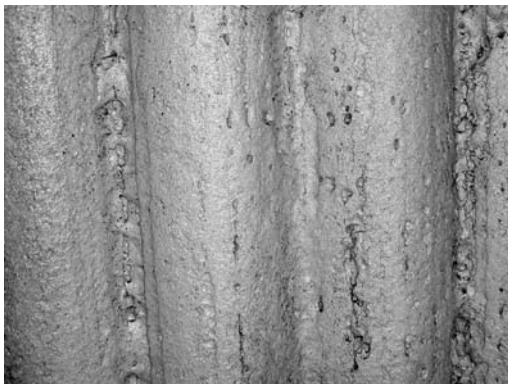
Fig. 12.22 Pitting attack is the common mode of corrosion of alloy 625 weld overlay on the waterwall. Shown in the photograph are three tubes and three membranes.

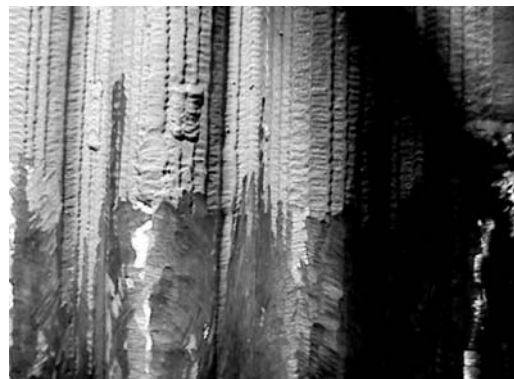
Fig. 12.23 Repair welding can be performed on the corroded waterwall overlay by grinding followed by overlay welding. An alloy 625 weld overlay on the waterwall after 10 years of service in a RDF unit. Shown in the photograph are two tubes and three membranes.

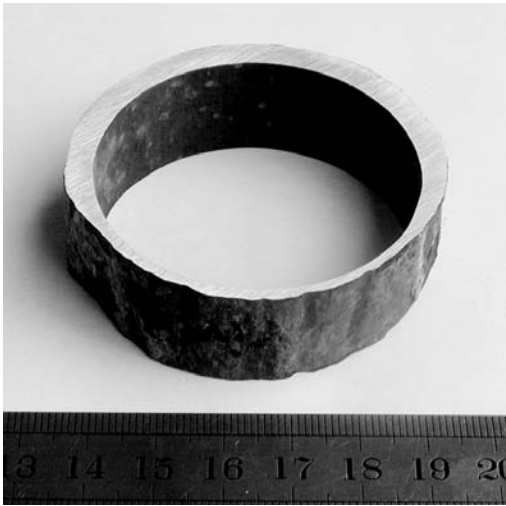
Fig. 12.24 Carbon steel (SA178A) superheater tube after 11 months of service in a mass-burning unit. The superheated steam temperature and pressure were 400 °C (750 °F) and 4.5 MPa (625 psig), respectively. Courtesy of Welding Services Inc.

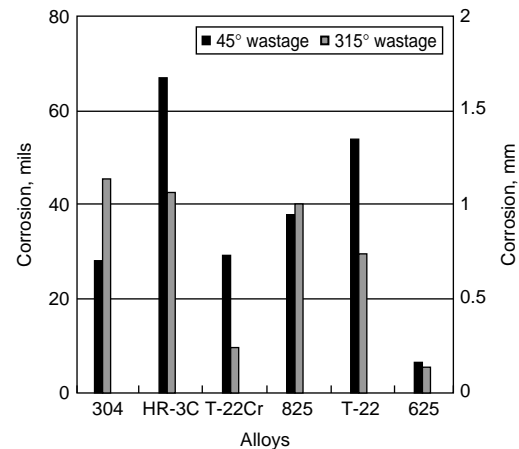
Fig. 12.27 Tube metal loss of various alloys tested at 470 °C (880 °F) for 1180 h in an RDF unit at Elk River Station. T-22CR represents the chromized T-22 tube sample. The chromized layer (on T-22) was found to be consumed in a large area. Source: Ref 37

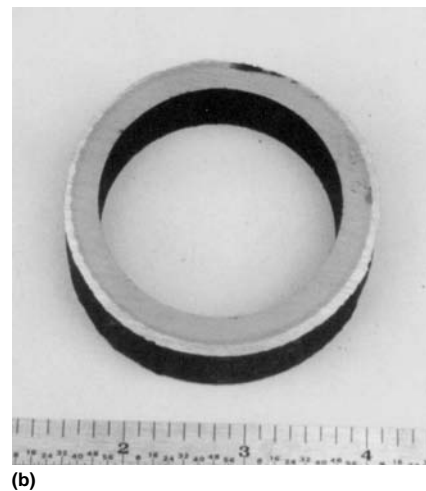
Fig. 12.29 Alloys 72 overlay superheater tube (a) and alloy C276 overlay superheater tube (b) after 7200 operating hours (10 months) in a RDF unit. The windward side of the tube, where the flue gas impinged upon the tube surface was the top side of the tube cross section as shown in the figure. The tube cross section was polished and etched with nital to reveal alloy 625 overlay (white portion of the metal) which was not etched by nital. Courtesy of Welding Services Inc.

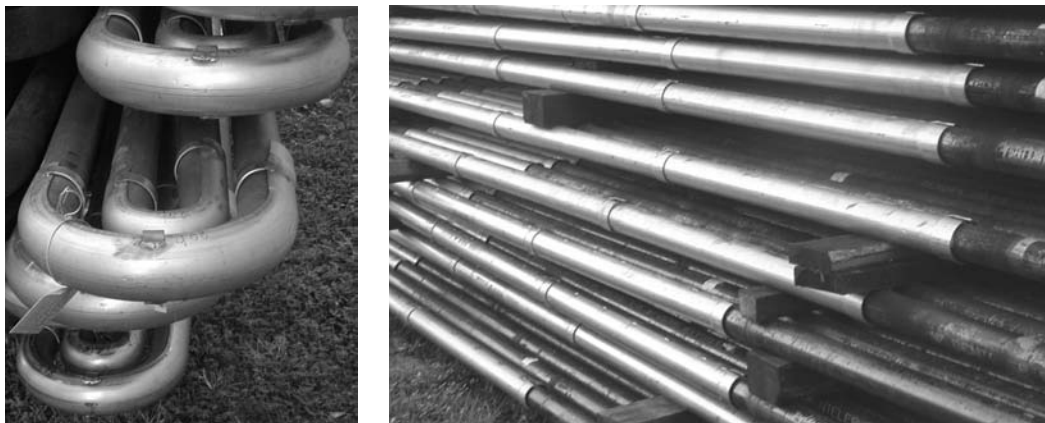
Fig. 12.30 Carbon steel superheater tubes protected by metallic tube shields awaiting installation at one WTE plant.
